**DEPARTMENT OF TRANSPORTATION**

Contract #: 04-0120F4Cty: SF/ALA Rte: 80 PM: 13.2/13.9File #: 69.28**WELDING INSPECTION REPORT****Resident Engineer:**Pursell, Gary**Address:** 333 Burma Road**City:** Oakland, CA 94607**Report No:** WIR-003173**Date Inspected:** 17-Jun-2008**Project Name:** SAS Superstructure**OSM Arrival Time:** 700**Prime Contractor:** American Bridge/Fluor Enterprises, a JV**OSM Departure Time:** 1700**Contractor:** Zhenhua Port Machinery Company, Ltd (ZPMC), Changxing Island **Location:** Shanghai, China**CWI Name:** Sun Wei**CWI Present:** Yes No**Inspected CWI report:** Yes No N/A**Rod Oven in Use:** Yes No N/A**Electrode to specification:** Yes No N/A**Weld Procedures Followed:** Yes No N/A**Qualified Welders:** Yes No N/A**Verified Joint Fit-up:** Yes No N/A**Approved Drawings:** Yes No N/A**Approved WPS:** Yes No N/A**Delayed / Cancelled:** Yes No N/A**Bridge No:** 34-0006**Component:** OBG and Tower**Summary of Items Observed:**

**OBG Sub-Assembly Bay 1**

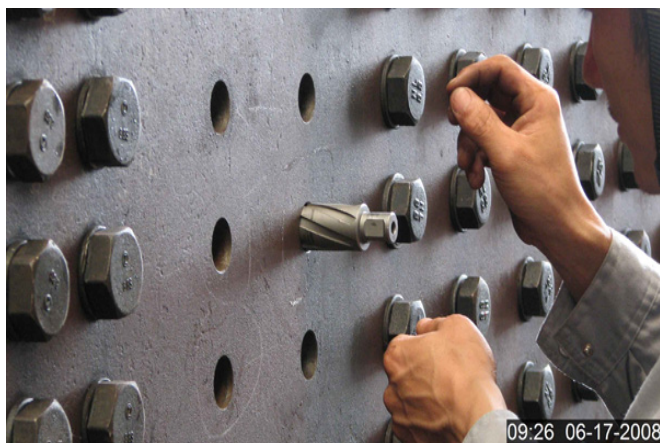
The Quality Assurance Inspector observed ZPMC manually reaming bolt holes with a socket wrench from the exterior of the 114M Tower Mock-up, exterior bolted connection plate. Below is a digital photograph illustrating the work in progress.

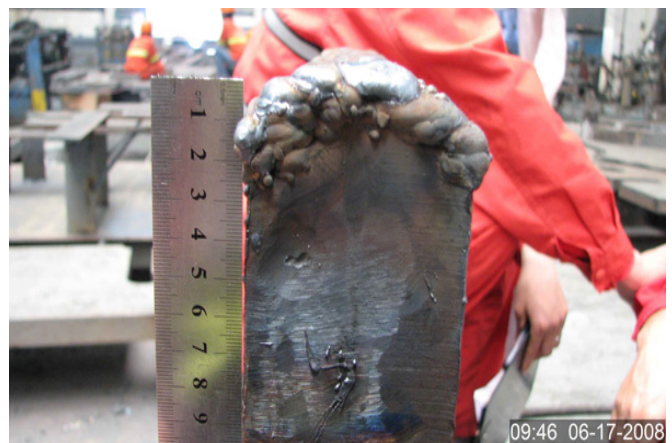
The Quality Assurance Inspector observed the build up by welding of Diaphragm Flange for joint ESD1-SA317 6A/16B. It appeared the welding was performed the previous shift and its not known what welding procedure specification was used to perform the welding. The Quality Assurance measured the amount of build up to be approximately 18 millimeters. The build up was being performed in an effort to make the root opening of the complete joint penetration splice within tolerances. Below is a digital photograph illustrating the build up.
